# TECHNICAL BULLETIN

## I300 Isolator Modules

**July 11, 2005**

**Document FLTB05-07-1**

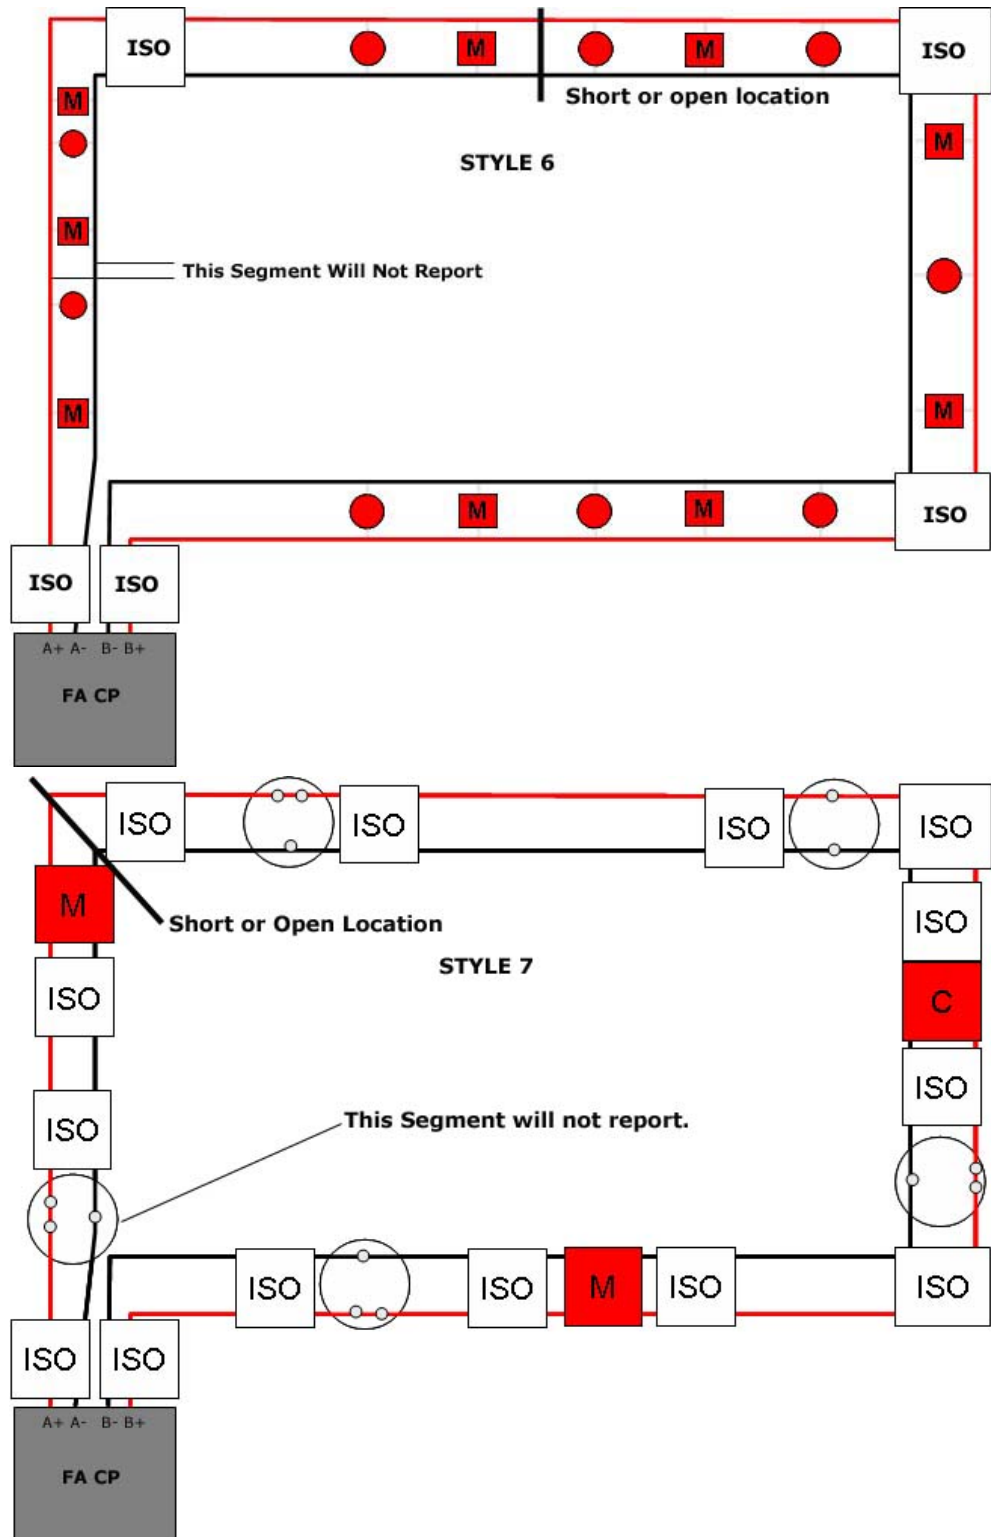
It has come to our attention that the operation described above is not working as intended. During a loop fault such as an open or short, the panel does report a SLC loop open trouble message. However, devices located between the break or open and the "A+" side of the panel will fail to report any detectors in alarm. (See drawings on next page)

To correct this problem, customers are advised to contact tech support to obtain the latest panel software. For the MS-9600 please request version 2.5. For the MS-9200UD, request version 2.3.

Note that the operation has also changed. In previous software versions, the system would constantly check the loop to see if the trouble had been cleared. If cleared, the system would automatically reinitialize the loop. The new version requires the user to perform a manual reset after repairing the short or open.
