## TECHNICAL BULLETIN

### MS-5UD and MS-10UD

Document FLTB07-10-01

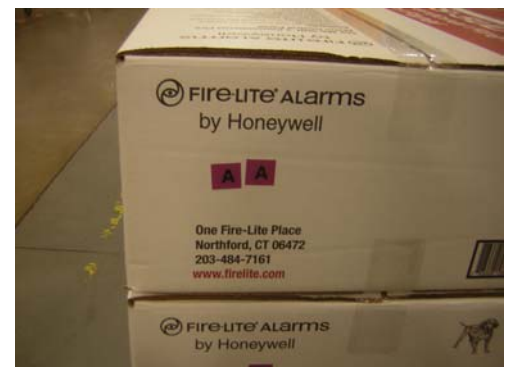
The MS-5UD and MS-10UD are now shipping with this updated version of software installed. Customers can determine if their shelf stock contains the updated software as it is identified by a purple date code stamp with two A's (AA) instead of just one (See carton photo below).
