# UDACT-F Field Software Change Procedure

Document 50317 Rev D 11/12/04 ECN 04-640

## Firmware Change

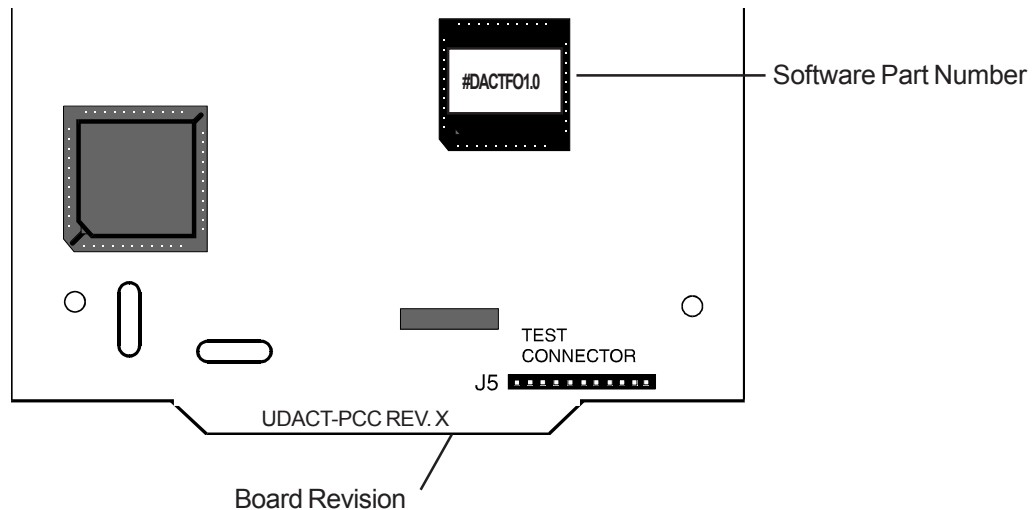
The board revision letter is located at the bottom of the UDACT-F board, centered on the mounting tab as illustrated below. The information appears as follows:

**UDACT-PCC REV X**

where X represents the revision letter. Use this letter to determine which PROM chip to use.

The software PROM Number is located on the PROM label.

- ✓ For REV H or earlier boards, software PROM chips with Part Number DACTF01.0 or earlier must be used. The UDACT-F will not operate with later version EPROMs
- ✓ For REV I or later boards, software PROM chips with Part Number DACTF02.0 or later must be used. Note that earlier versions of the EPROM can be used but it will not contain the latest software enhancements
