MS-9200(C)/E Field Software Change Procedure (and Programming Existing MS-9200 Systems for use with the LCD-40)

Document #50053 Rev. M 1/10/08
ECN 08-019 P/N 50053:M

Firmware Change

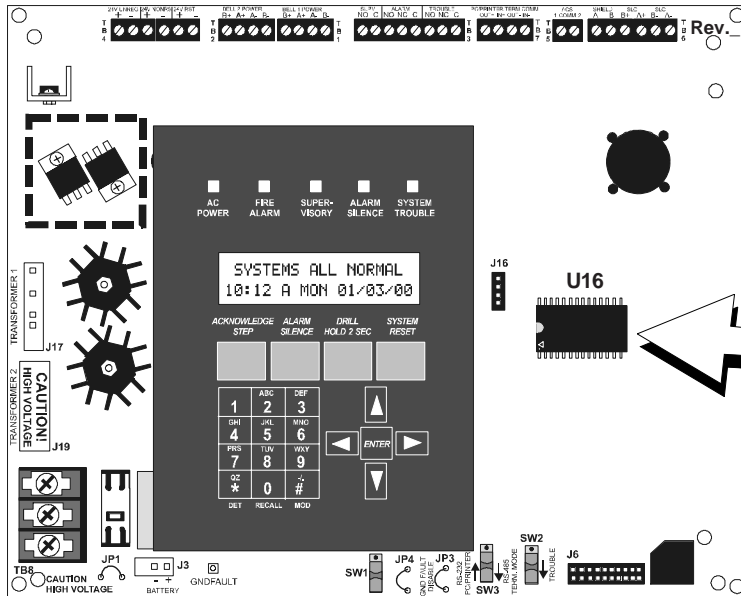
← EPROM (U16)
(newer boards)

← Circuit Board assembly information (Rev.) can be found in the upper right corner of the circuit board.

1. Make certain Software Revision and Circuit Board Revision are compatible (refer to table on page 4).
2. Once all power has been removed, disconnect any optional modules (if installed).
3. Locate EPROM U16 on newer boards or U14 on older boards (center right of the board).
4. Gently loosen and remove EPROM from the board.
5. Install replacement EPROM. Observe proper orientation! The notch or dot on the IC should be positioned to the left for U16 in the newer boards or to the right for U14 in older boards as shown below. Use care to insure that the EPROM's pins are not bent or broken during insertion.
6. Reconnect power supplies.

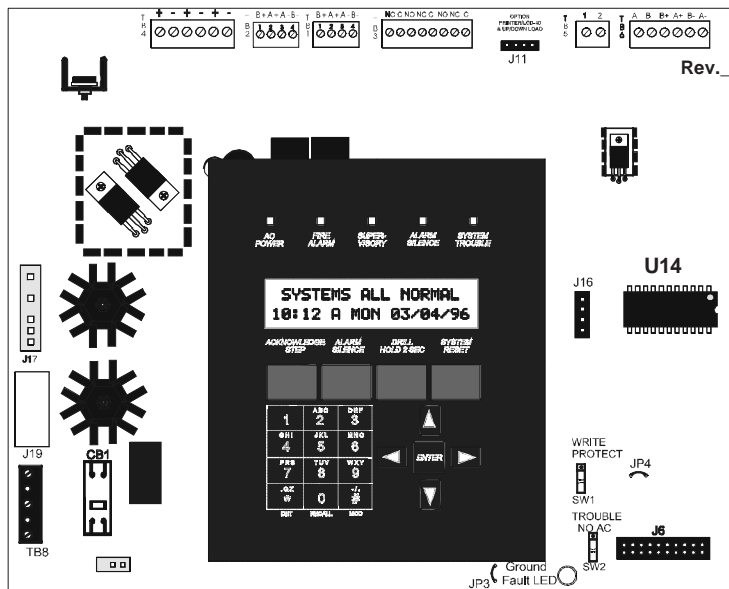
← EPROM (U14)
(older boards)

← Circuit Board assembly information (Rev.) can be found in the upper right corner of the circuit board.
