# UDACT-F Field Software Change Procedure

Document 50317 Rev D 11/12/04 ECN 04-640

## Firmware Change

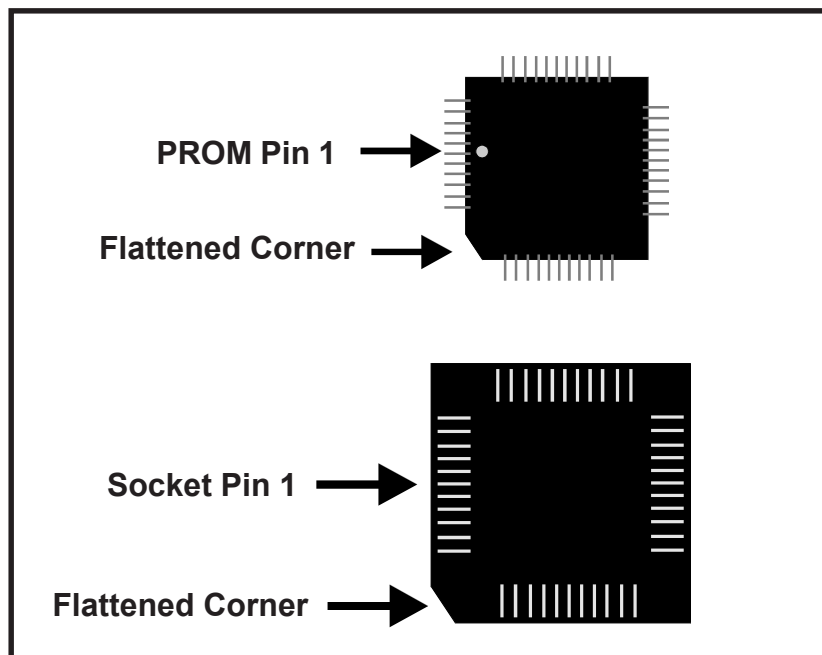
Observe proper orientation of any IC removed or installed! Note location of Pin 1 with respect to the flattened corner and dot on the body of the IC and the relationship to the flattened corner on the IC socket. The replacement PROM must be installed in the same manner as the PROM removed. Failure to observe this orientation will result in destruction of the PROM.
