MS-9200(C)/E Field Software Change Procedure (and Programming Existing MS-9200 Systems for use with the LCD-40)

Document #50053 Rev. M 1/10/08
ECN 08-019 P/N 50053:M

Firmware Change

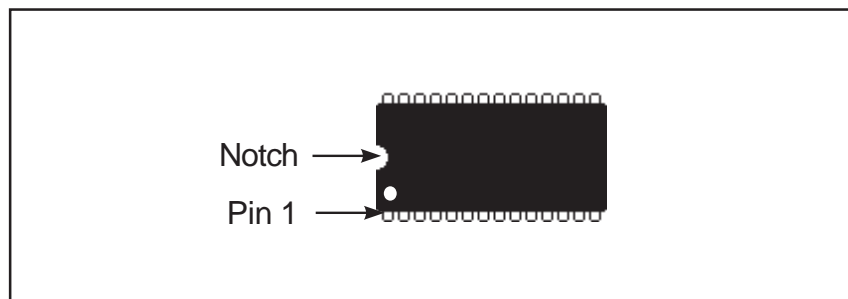
Observe proper orientation of any IC removed or installed! Note location of Pin 1 with respect to the notch in the body of the IC. The replacement EPROM must be installed in the same manner as the EPROM removed. Failure to observe this orientation will result in destruction of the EPROM. *NOTE: Some ICs may have a small dot instead of a notch for orientation purposes.*
