# SLC and Addressable Device Troubles

## SLC Distances and Wiring

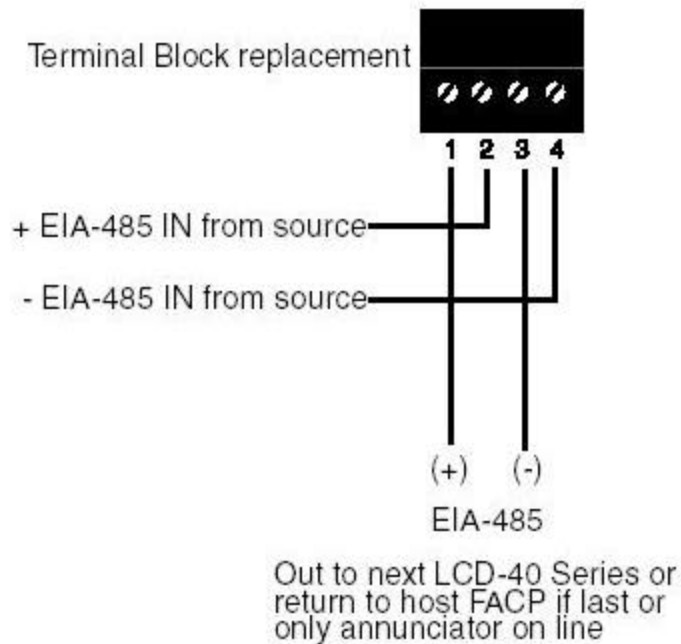
The LCD-40 requires a total of 6 wires for proper operation. Two wires are needed for power, and 4 are needed for communication, out and return. This 4 conductor should be a minimum of 18AWG, twisted shielded.

The proper terminations for connecting a LCD 40 to the system shall look like this.

MS 9200	LCD-40
TB7 or DIM-485	P1 connector

Terminal 1 Out +	Terminal 2 In +
Terminal 2 In +	Terminal 1 Out +
Terminal 3 Out -	Terminal 4 In -
Terminal 4 In -	Terminal 3 Out -
